## §29. First Overhaul and Control-System Improvement of 250 MVA Motor-Generator

Kitagawa, S., Kato, A., Mizuno, Y., Hayakawa, A. (Toshiba Corporation)

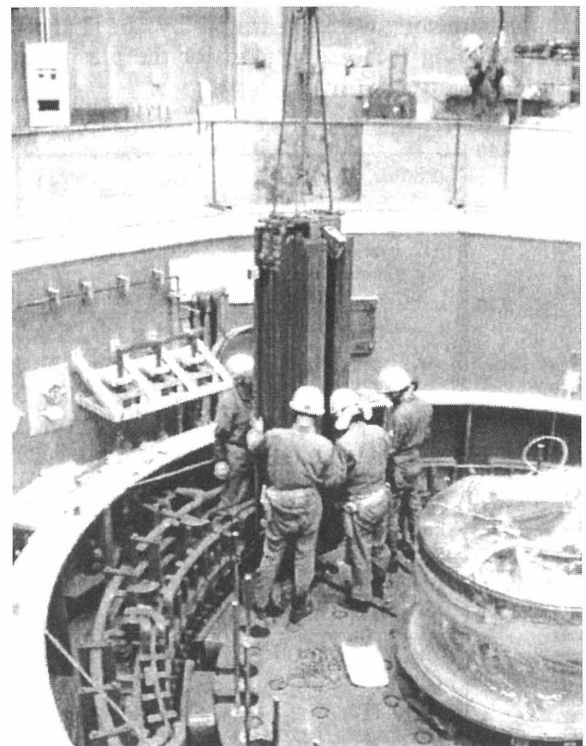
Since the MG is of vertical shaft type, the motor was first dismantled and removed. After taking out the upper bearing bracket and fixing of the generator's rotor, then 16 pole-pieces were all pulled up and checked. Figure 1 shows a photograph under pulling-up work of a generator's pole-piece. As the time is limited, the main bodies of stator and rotor were not demounted.

Fig. 1. Operation during pulling-up of generator pole-piece
