§64. Surface Analysis of the LHD Divertor Tiles

Sagara, A., Masuzaki, S., Morisaki, T., Noda, N.

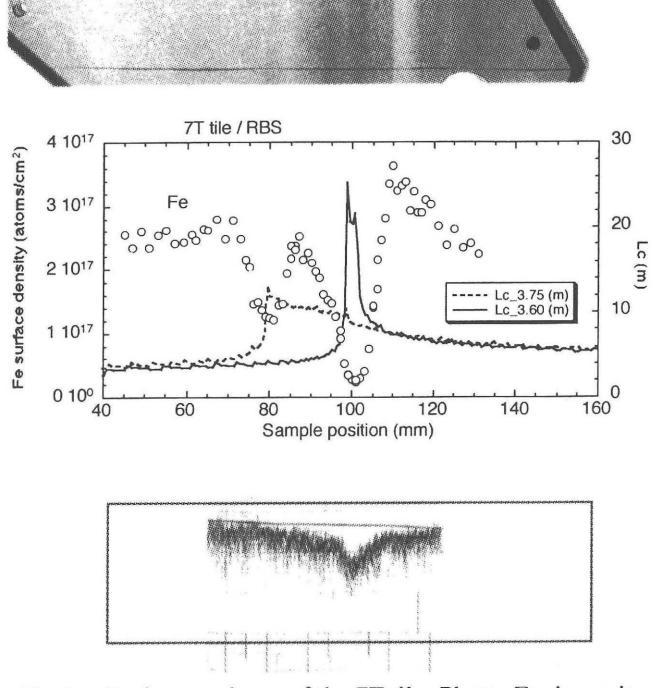
Deposited metal impurities such as Fe of about $2x10^{17}$ atoms/cm² was generally observed on the tiles mainly due to re-deposition of the 316 stainless steel chamber wall sputtered under glow discharge cleaning for the total 2,300 hrs. On the 7T tile, as shown in Fig.1, there were 2 distinctive traces with little amount of metals and eroded about 9µm. These traces correspond well to the hitting positions of the divertor leg within several mm in accuracy.

Fig.1 Surface analyses of the 7T tile: Photo, Fe -impurity distribution and surface profilometory .

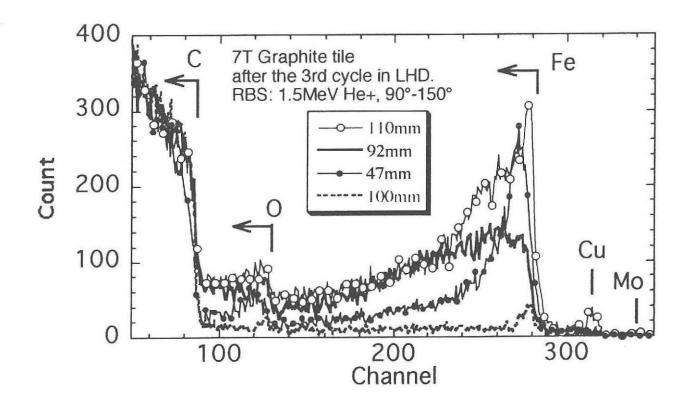
Fig.3 RBS analysis of each position on the 7T tile.
