**Investigation of irradiation effects on highly integrated leading edge
electronic components of diagnostics and control systems for the LHD
deuterium operation**

Abstract. High-temperature and high-density plasmas are achieved by means of real time control, fast diagnostic, and high power heating systems. Those systems are precisely controlled by means of highly integrated electronic components. However, the radiation damage leads to serious impact on those systems. Therefore, the effects due to irradiation on electronic components being used currently should be investigated for control and measurement of Large Helical Device (LHD) deuterium plasmas. For precise estimation of the radiation field in the LHD torus hall, MCNP6 code is used with the cross-section library of ENDF B-VI. The

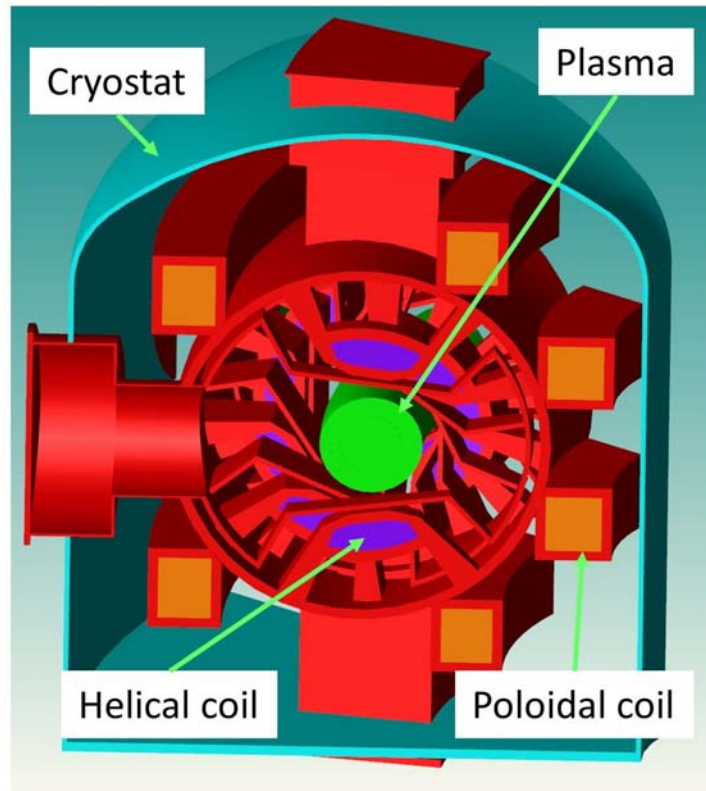
Fig. 1. MCNP Model of LHD. The figure is made with SuperMC [8, 9]

For precise estimation of the radiation field in the LHD torus hall, MCNP6 three-dimensional Monte-Carlo neutronics code [6] is used with the cross-section library of ENDF B-VI [7]. In the MCNP calculation geometry, the LHD components within the support structure are divided by small toroidal angle pitch, and the components are assumed to be toroidally symmetric in a toroidal pitch angle. The geometry in one toroidal pitch angle is modelled based on the CAD drawing with some simplification (Fig. 1). The neutron source is isotropic and homogeneous in the torus with the energy of 2.45 MeV. A three-dimensional map of the radiation field in the LHD torus hall has been obtained. Figure 2 a shows the neutron flux profile in the LHD torus hall and the profile in the basement level of the torus hall at the maximum neutron emission discharge (total neutron emission rate of $1.9 \times 10^{16} \text{ s}^{-1}$). It is found that the neutron flux in the torus hall, and the flux in the basement level are around $10^9 \text{ cm}^{-2}\text{s}^{-1}$ and around $10^6 \text{ cm}^{-2}\text{s}^{-1}$, respectively. Figure 2 b shows the profiles of the dose on silicon (Si),

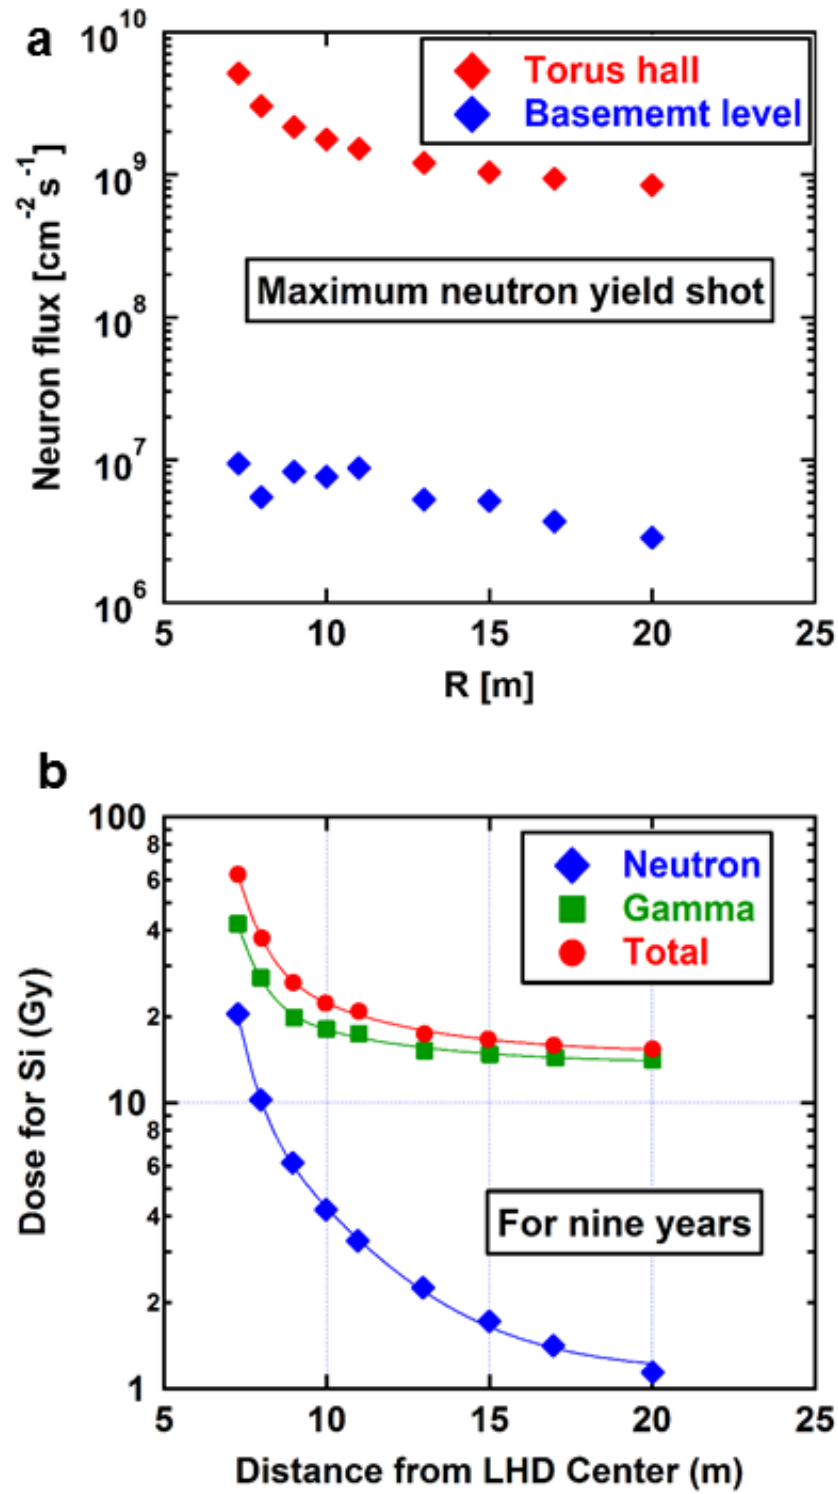
Fig. 2 a). Neutron flux profile in the LHD torus hall. b). Dose profile for Si in the LHD torus hall.

which is a major ingredient of electronics components, during the nine years of the LHD deuterium operation. The gamma-ray contributions are dominant in dose.

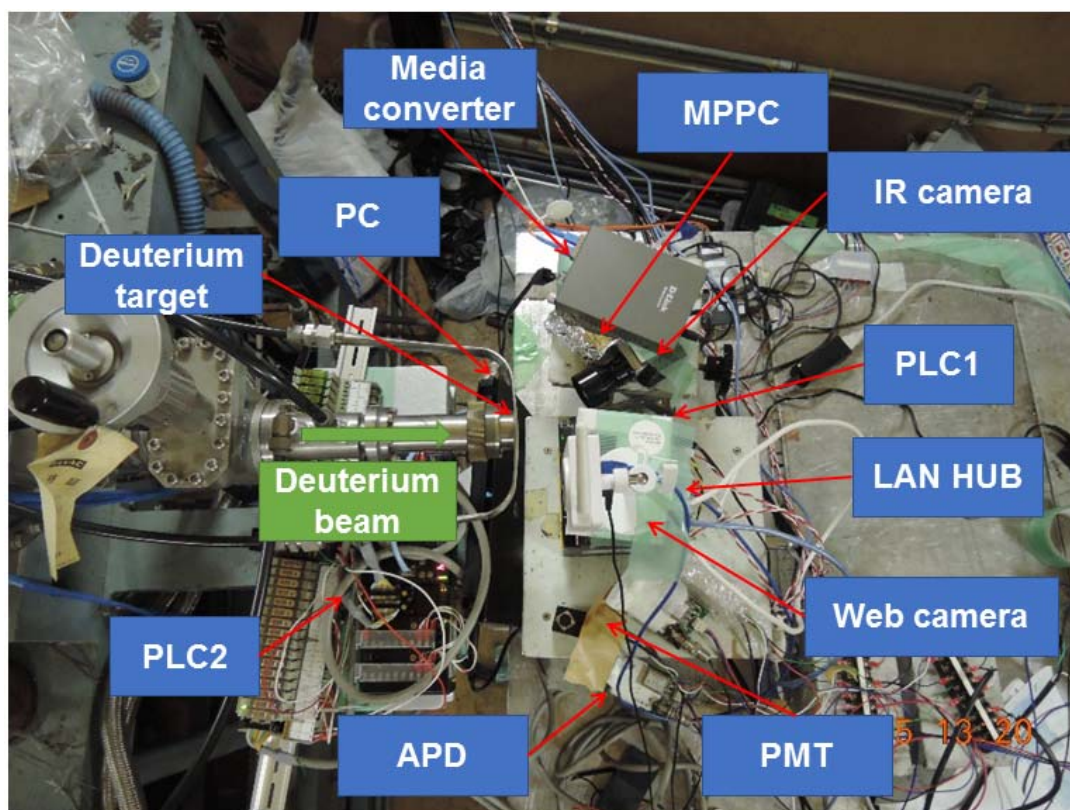
Fig.3 Arrangement of neutron irradiation test in OKTAVIAN.

To investigate the irradiation effect on electronic components used in the LHD torus hall, neutron irradiation tests are performed in the Fast Neutron Laboratory (FNL) at Tohoku University [10] and OKTAVIAN [11]. A PC, a media converter, an infrared (IR) camera, a multi-pixel photon counter (MPPC), a web camera, two avalanche photodiode (APDs), two photomultiplier tubes (PMTs), and PLCs are tested (Fig. 3). In the experiment performed in OKTAVIAN, the total neutron emission rate from the target is up to $9 \times 10^8 \text{ s}^{-1}$, therefore, the neutron flux at 5 cm away from the target, and the flux at 10 cm away from the target are up to $3 \times 10^6 \text{ cm}^{-2}\text{s}^{-1}$ and $7 \times 10^5 \text{ cm}^{-2}\text{s}^{-1}$, respectively. The neutron exposure has been performed for 11.5 hours. The neutron flux in this experiment is two or three orders smaller than the neutron flux in the LHD torus hall and in the same order as the neutron flux in the basement level of the torus hall. The status of all components is monitored remotely from the control room. The results of neutron exposure test are summarized in Table 1. Transient effects due to neutron irradiation are observed on a PC, an IR camera, a web camera, APDs, PMTs and a PLC. Disconnection of the network is observed on the PC at neutron flux of $3 \times 10^5 \text{ cm}^{-2}\text{s}^{-1}$. The frequency of this effect is once per 11 hours. If we assume that the frequency increases linearly with the neutron flux, the PC placed in the torus hall without any shield will experience a disconnection of the network up to once per four shots at the maximum neutron emission discharge of LHD. Here, we assume that the frequency increases linearly because the both ionisation and displacement damage due to radiation on the semiconductor materials increase linearly with the radiation fluence [12]. Note that we classify the effect as transient because the disconnection of the network recovers due to the reboot. Temporal dead pixels

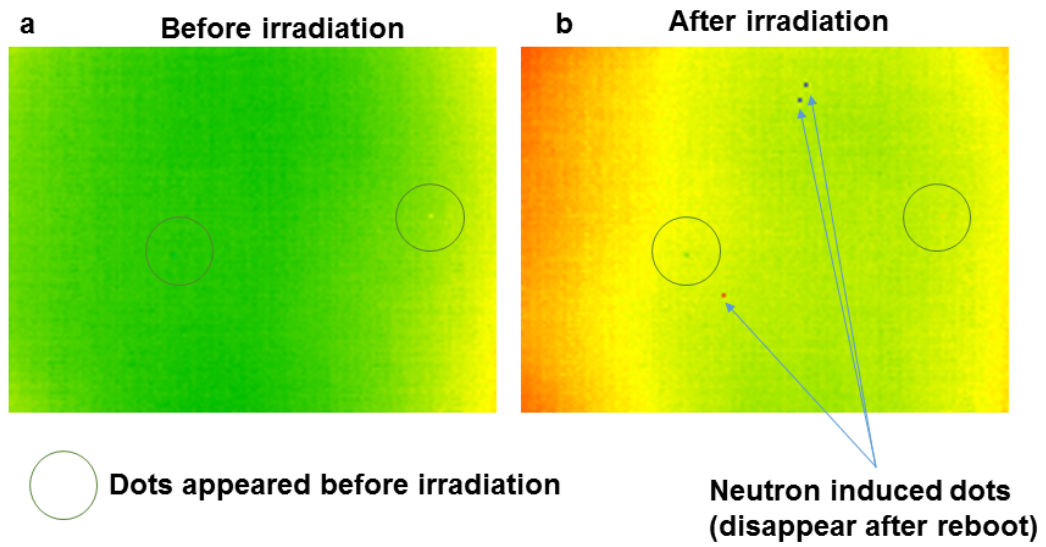
Fig.4 IR camera image taken (a) before neutron irradiation and (b) after neutron irradiation.

due to neutrons appear on the IR camera (Fig. 4). We observed four dots per 3 hours at neutron flux of $7 \times 10^5 \text{ cm}^{-2}\text{s}^{-1}$. Note that the temperature shown in dead pixels is always zero. The IR camera will be installed on the upper port of LHD where expected maximum neutron flux is $10^{10} \text{ cm}^{-2}\text{s}^{-1}$. If the number of dots linearly grows as neutron flux, the number of dead pixels due to neutrons will reach 2 dots per shot. Note that the effect is transient because the dead pixels due to neutrons recover due to reboot. The loss of the image is obtained on the web camera at the neutron flux of $3 \times 10^6 \text{ cm}^{-2}\text{s}^{-1}$ whereas on the neutron flux of less than $3 \times 10^5 \text{ cm}^{-2}\text{s}^{-1}$ the image transfer has no problem. At first, green on the web camera disappears (Fig. 5), therefore, the movie completely disappears even though the connection between the web camera and a PC is stable. The effect is observed once per 11.5 hours, and the expected failure rate in the LHD torus hall is once per forty shots. In PMTs and APDs, we observed neutron-induced pulse with frequency of 23 Hz and 1.5 Hz, respectively. If we put the PMTs and APDs near LHD, where the neutron flux will be $10^{10} \text{ cm}^{-2}\text{s}^{-1}$, we will obtain neutron induced pulse with frequency of 115 kHz and 7.5 kHz, respectively. We observed neutron-induced error at neutron flux of $3 \times 10^6 \text{ cm}^{-2}\text{s}^{-1}$ whereas at neutron flux of $3 \times 10^5 \text{ cm}^{-2}\text{s}^{-1}$ no error is observed on PLC modules. Neutron-induced errors occurred on the PLC three times per 9 hours (Fig. 6). The behaviour of the AC output module is different in each case. In the first case, the output voltage becomes zero when disconnection of the network occurs. However, the second time, the output voltage stays the same even though the network is disconnected. Moreover, the third time, the output voltage shows 10 V (maximum) when disconnection of the network occurs. Note that no permanent effect is observed in this experiment.

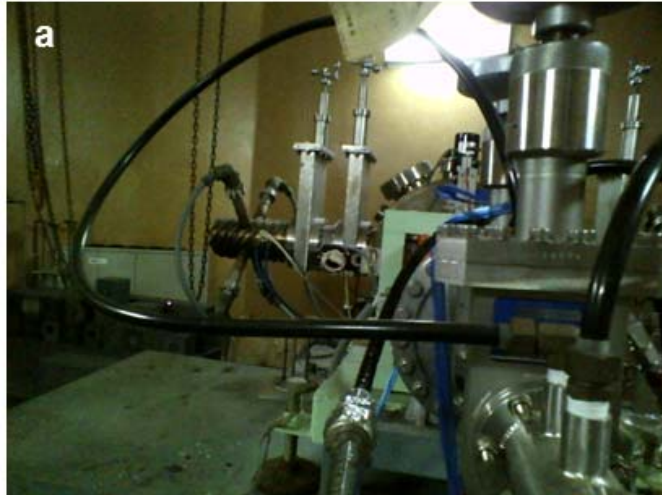
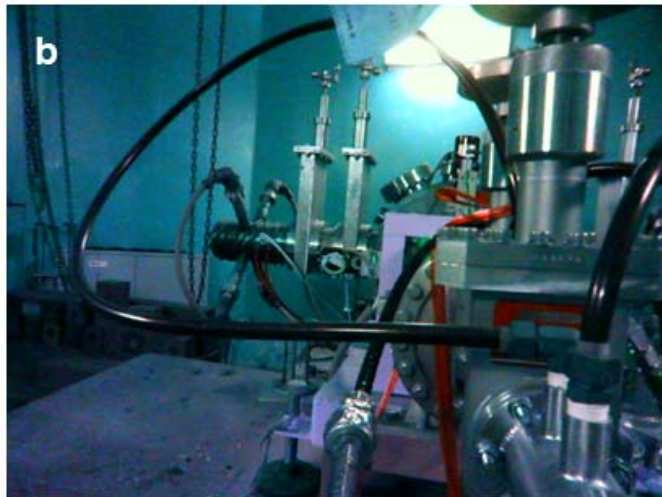
Fig. 5 (a) Normal web camera image. (b) Green on web camera disappears due to neutron irradiation.

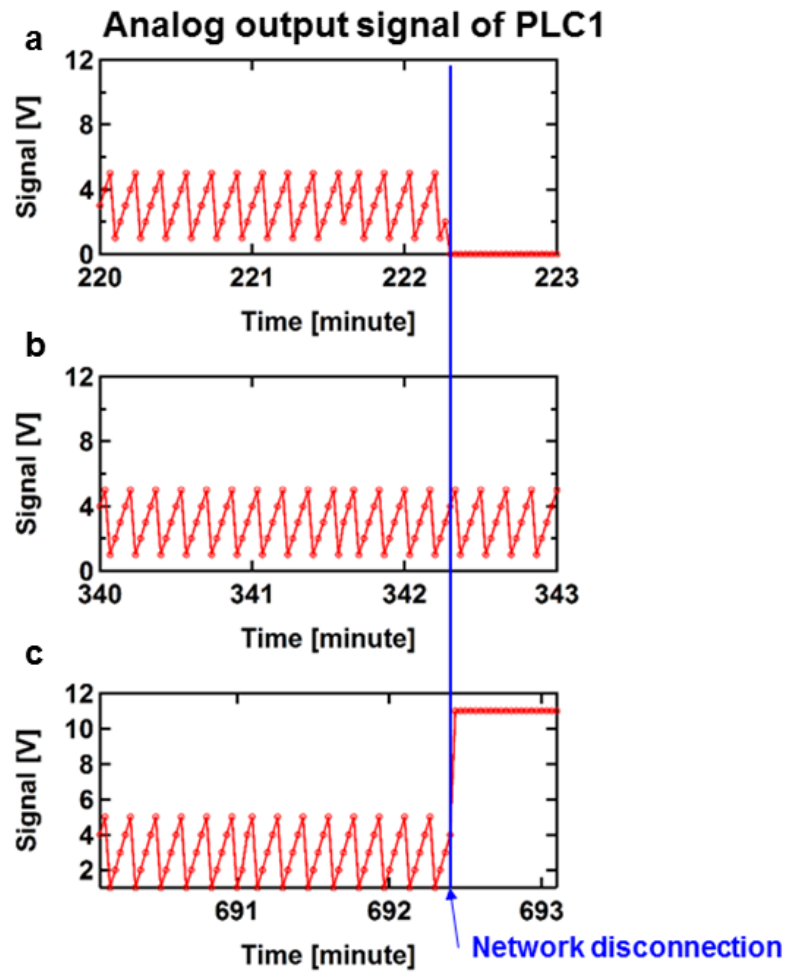
Fig. 6. Time evolution of analog output signal of PLC1. (a) The output voltage becomes zero when disconnection of the network occurs. (b) The output voltage stays the same even though the network is disconnected. (c) The output voltage shows 10 V (maximum) when disconnection of the network occurs.

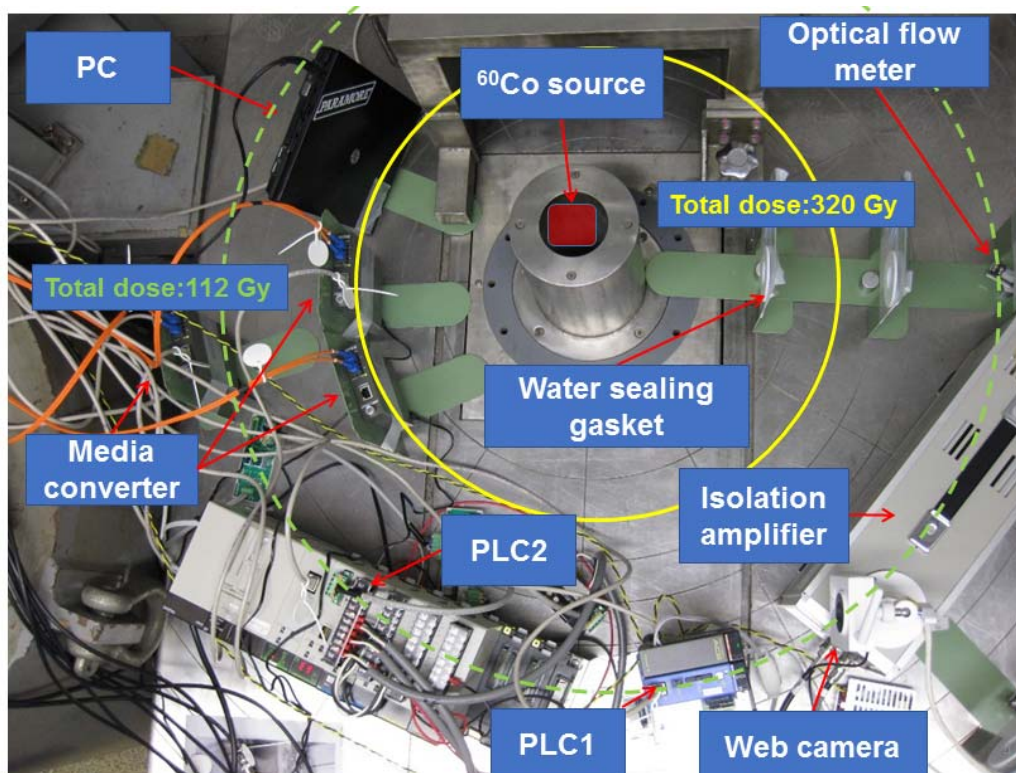
Fig. 7. Arrangement of gamma-ray irradiation test in Nagoya University Cobalt-60 irradiation facility

Gamma-ray irradiation tests are performed in the Nagoya University Cobalt-60 irradiation facility [13]. A PC, two media converters, two optical flow meters, two isolation amplifiers, a web camera, and two PLCs were irradiated (Fig. 7). The gamma-ray dose rate to the silicon (Si), which is a major ingredient of electronics components, evaluated by calculation on the day of the experiment (2015/7/14) is 190 Gy/h at 20 cm from the source, 86 Gy/h at 30 cm from the source, and 30 Gy/h at 50 cm from the source. The results of gamma-ray exposure are summarized in Table 2. No transient effect is seen except for the web camera and the analog terminal of the PLC at the dose rate of 38 Gy/h. The PC is broken at the integrated gamma-ray dose of 224 Gy. The connection of two media converters is stable after the integration dose of 320 Gy. The signal of two optical flow meters is unchanged after the integration dose of 240 Gy. The output signal from the isolation amplifier is stable after the integration dose of 112 Gy. The dot noise due to gamma-ray is observed on web camera. This effect is only observed during the gamma-ray exposure. The output signal from PLC1 and PLC2 is monitored by a PC through the network. The increase of the offset of the analog output is observed from the beginning of the analog output from analog output module (DA04-IN) of PLC1 (Fig. 8). The output signal disappears when the integrated dose reaches 86 Gy, because the connections between the PLC1 and the PC is broken. The mismatch of input and output signals is observed on analog output module (CS1W-DA08V) and Devicenet input module (CS1W-DRM21-V1) of PLC2 at 95 Gy (Fig. 9 a) whereas DA output and AD input signals are same (Fig. 9 b). Both signals disappear at 112 Gy because of CPU-module broke. We tried to reboot both PLCs by inserting and pulling out the power supply plug of the electric apparatus. However, there was no reaction from both PLCs. We found that modules of the PLC are broken around the dose of 100 Gy. This is comparable with the dose in the LHD torus hall over nine years, and the dose is one order smaller than the threshold of the

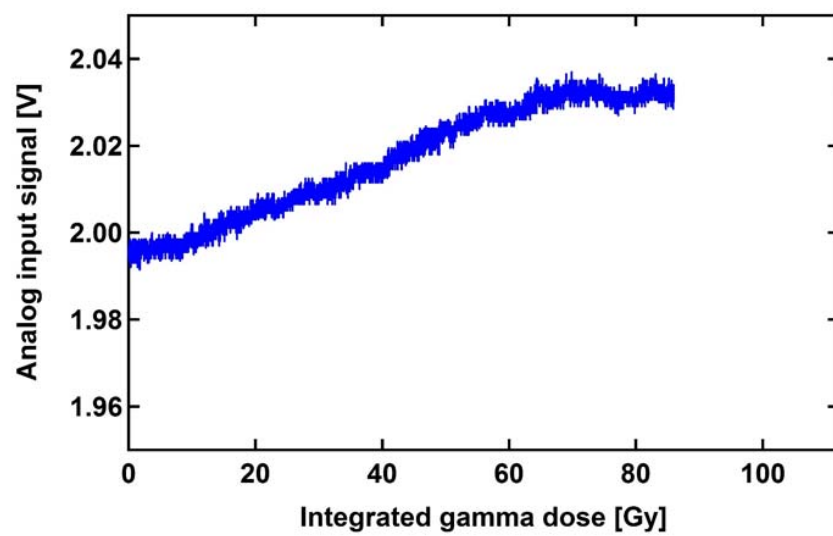
Fig. 8 Offset increase on analog output module due to gamma-ray irradiation.

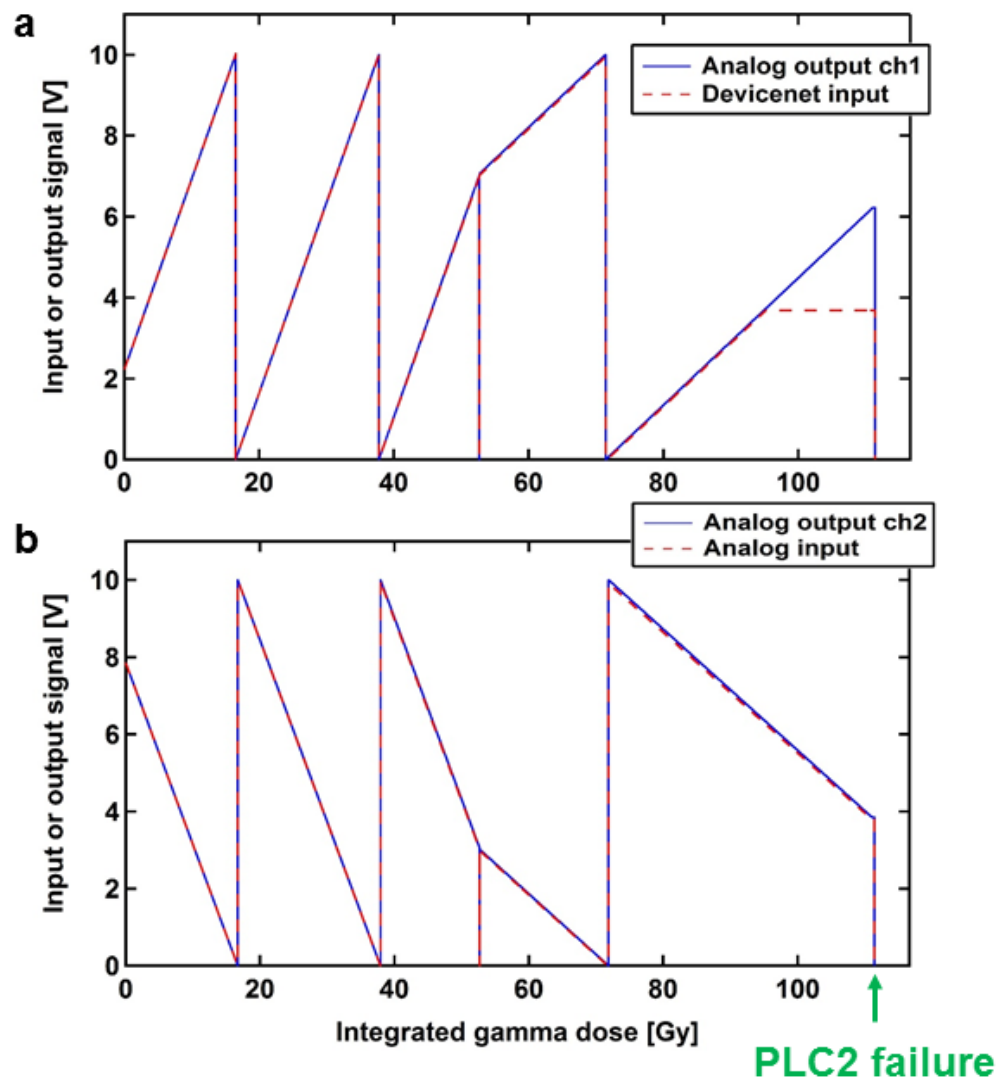
Fig. 9 (a) The mismatch of input and output signals is observed. (b) Both signals have same trend until PLC2 broken.
