## §14. Basic Study on Self-Healing of $\text{Er}_2\text{O}_3$ Coating for Vanadium-Lithium Blanket System

Terai, T., Suzuki, A., Chikada, T. (The University of Tokyo), Yao, Z., Muroga, T.

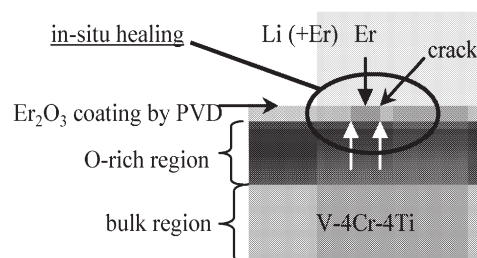
Fig. 1 The scheme of self-healing coating.

A self-cooled liquid lithium/vanadium-alloy blanket system is attractive from the viewpoint of energetic conversion efficiency and tritium breeding ratio. One of the critical issues involved in this system is magneto-hydrodynamics (MHD) pressure drop, which is induced by liquid metal flowing across strong magnetic fields. In order to reduce MHD pressure drop to acceptable levels, fabrication of thin insulating coatings at inner wall of duct tubing has been proposed. In the previous studies, erbium oxide ( $\text{Er}_2\text{O}_3$ ) was selected as one of the best candidate oxide materials for the MHD coating from the point of view of compatibility with lithium [1]. And recently  $\text{Er}_2\text{O}_3$  coatings fabricated by PVD method showed high electrical resistance and high compatibility with liquid lithium [2]. In-situ formation of  $\text{Er}_2\text{O}_3$  coatings was also explored to show that oxygen in the V-alloy substrate and Er dissolved in lithium could react to form thin  $\text{Er}_2\text{O}_3$  layer at the interface [3]. In this report, feasibility of self-healing of  $\text{Er}_2\text{O}_3$  coating is explored by observing its in-situ formation at cracks on the coatings fabricated by PVD method as indicated in Fig. 1.

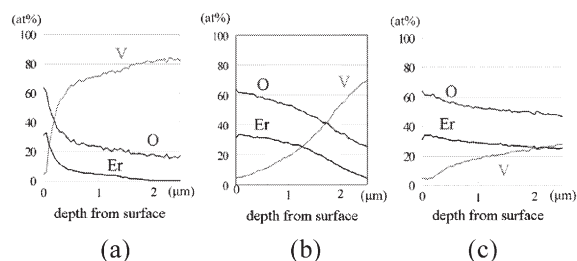
Fig. 2 Depth profiles of elements by XPS deposited by arc source plasma assisted deposition. (a) deposited at R.T. (b) deposited at 973K (c) annealed for 3h at 873K after deposition

To ascertain mechanism of peel-off and healing, depth profiles of elements in  $\text{Er}_2\text{O}_3$  coatings were analyzed by X-ray photoelectron spectroscopy (XPS) with Ar sputtering. As shown in Fig. 2, Er and O drastically and V increased near the surface in case of the sample deposited at R.T.. In contrast, those of samples deposited at 873 K and heated after deposition at R.T. showed gradual decrease of Er and O and gradual increase of V. These indicated heating during or after deposition contributed to form Er-V-O intermediate layer between the coating and the substrate. It was suggested Er-V-O layer were formed by taking oxygen from substrate in case of oxidized substrates as well. It is considered

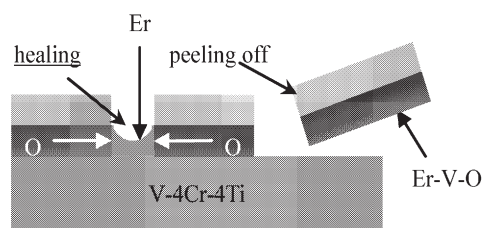
Fig. 3 Process of healing cracks and peeling V-Er-O layer.

Er-V-O layer itself has been peeled off and substrate without oxygen was remained on the surface, and therefore in-situ formation had not been observed at peeled-off area. At the small cracks which have healed, it is considered the oxygen was supplied from Er-V-O layer from the remained coatings at surroundings as indicated in Fig. 3. Thus, oxygen supply in the system, especially Er-V-O layer, is a key investigation point to control the healing of cracks on  $\text{Er}_2\text{O}_3$  coating at Li/V-alloy blanket.
