§103. Synergistic Effects of Neutron (ion) and Plasma on Material in QUEST

Watanabe, H., Yoshida, N. (RIAM Kyushu Univ.), Muroga, T., Kurishita, H. (Tohoku Uni.)

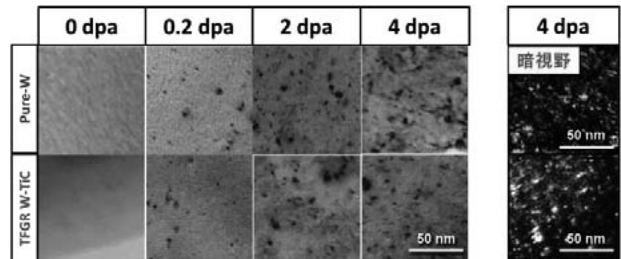
Fig.1 Microstructure of pure W and TFGR W-1.1TiC irradiated at room temperature.

In order to clarify the effect of radiation induced damage on D retention in W based materials with different microstructures, specimens of pure R-W (0.1mm thick sheet recrystallized at 2273K for 10 min,) and TFGR W-1.1TiC were employed. The pure W was electrolytically polished and TFGR W-1.1TiC was mechanically mirror polished followed by degassing at 1473 K for 5 min. The both specimens were irradiated with 2.4MeV-Cu²⁺ at room temperature up to 1×10^{19} ions/m² for pure W and 2×10^{19} ions/m² for TFGR W-1.1TiC, which correspond to 2 and 4 dpa (displacement per atom), respectively. The position of the peak damaged zone is around 400-500 nm from the surface. After the ion irradiation, the specimens were irradiated with 2.0 keV-D²⁺ at room temperature and higher temperature up to 1×10^{21} D²⁺/m² and subjected to TDS at temperatures from RT to 1023K in vacuum with an heating rate of 1 K/s. Fig. 1 and 2 show the microstructure of pure W and TFGR W-1.1TiC irradiated at room temperature. Fig. 1 and 2 show dislocation contrast images and void contrast images, respectively. By the irradiation, dislocation loops of interstitial type and a high density of nano-voids were observed in both materials. But, the microstructure of TFGR W-1.1TiC was almost same as the pure W. These results mean that the addition of 1.1TiC does not significant affects on the formation of dislocation loops and voids by the present irradiation conditions. Fig. 3 and 4 show the effects of displacement level (dpa) and irradiation temperature dependence of desorption rate of D₂ for pure W and TFGR W-1.1TiC, respectively. These results show that the sink density (dislocation loops and nano-voids) and resultant lattice defects due to 2.4MeV Cu²⁺ irradiation have significant effects of the desorption of D₂ in both pure W and TFGR W-1.1TiC.

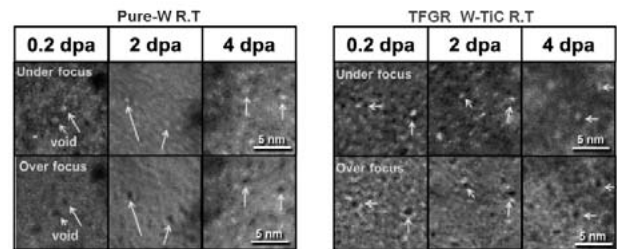
Fig.2 Void contrast image of pure W and TFGR W-1.1TiC irradiated at room temperature

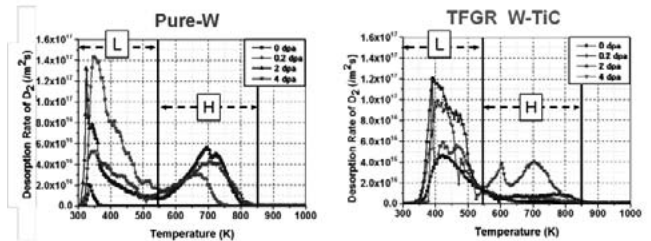
Fig.3 Effects of Cu ion irradiation on desorption of D₂ for pure W and TFGR W-1.1TiC irradiated at room temperature

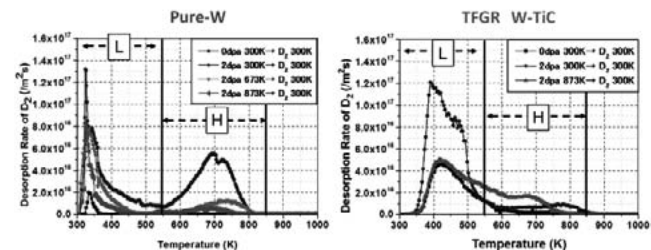
Fig. 4 Effects of higher temperature irradiation on desorption of D₂ for pure W and TFGR W-1.1TiC
